VI. Detailed Findings & Recommendations

B. Deficiency Elevation Drawing (East & West Elevations)

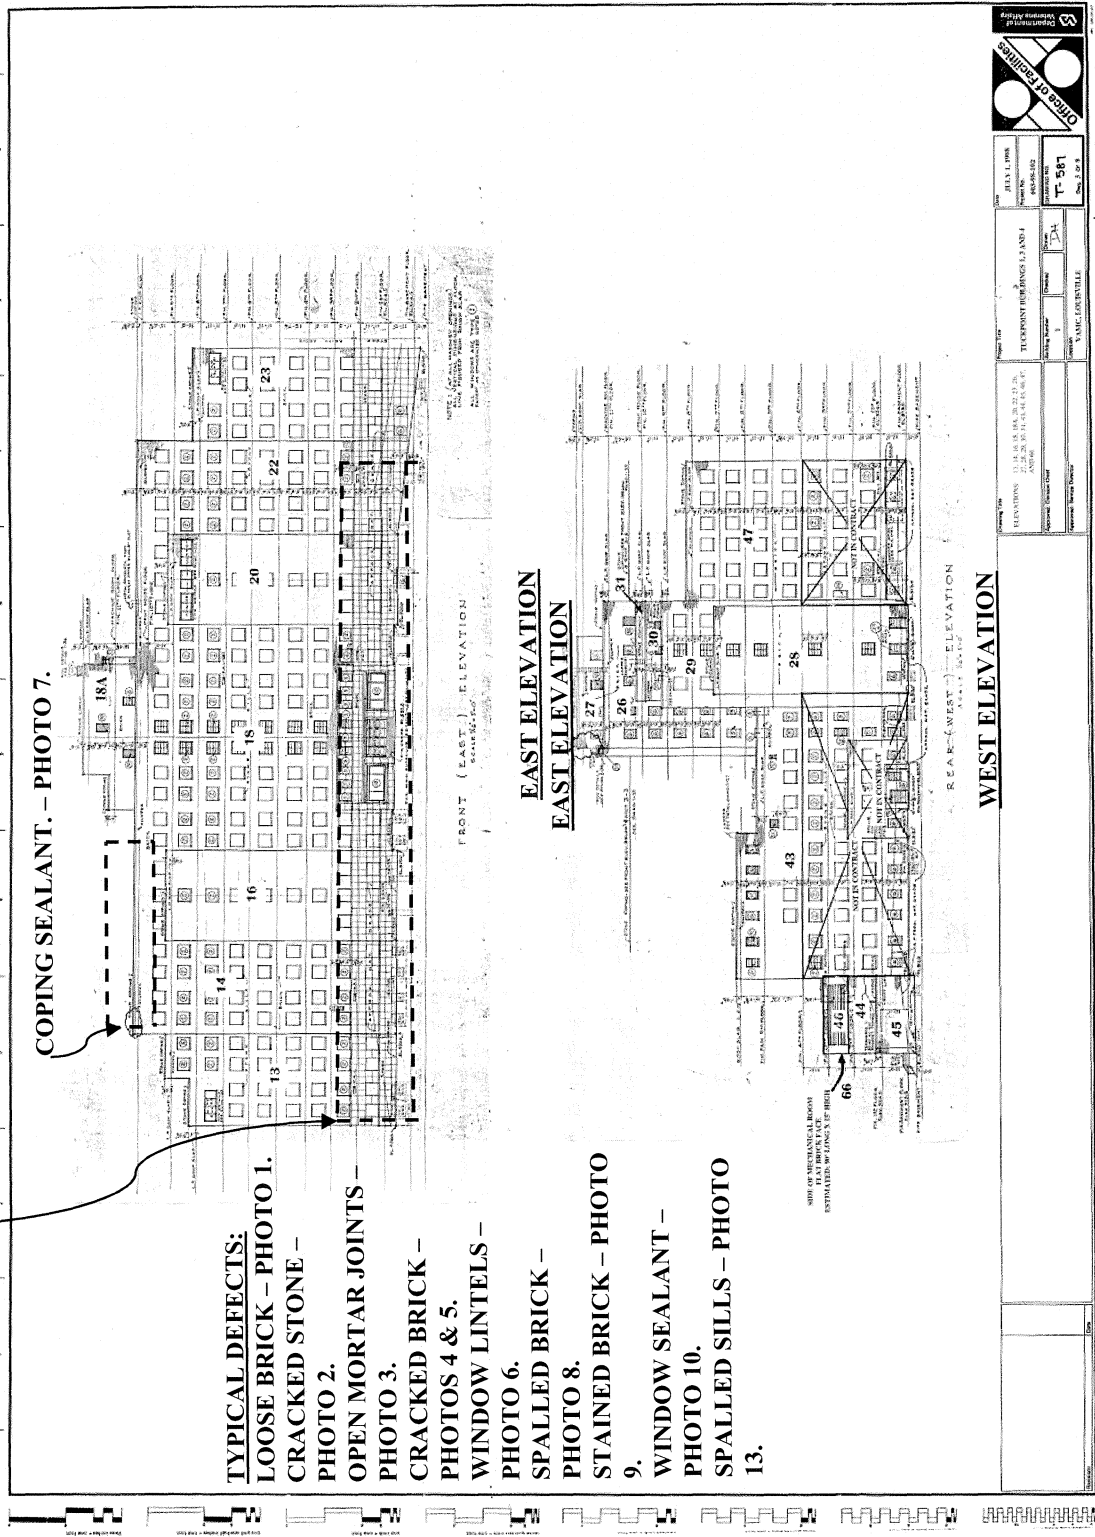
FAILED JOINT SEALANT AND CRACKED STONE
FACADE AREA - PHOTOS 2 AND 12.

COPING SEALANT. - PHOTO 7.

TYPICAL DEFECTS:

- LOOSE BRICK - PHOTO 1.
- CRACKED STONE -
PHOTO 2.
- OPEN MORTAR JOINTS -
PHOTO 3.
- CRACKED BRICK -
PHOTOS 4 & 5.
- WINDOW LINTELS -
PHOTO 6.
- SPALLED BRICK -
PHOTO 8.
- STAINED BRICK - PHOTO
9.
- WINDOW SEALANT -
PHOTO 10.
- SPALLED SILLS - PHOTO
13.

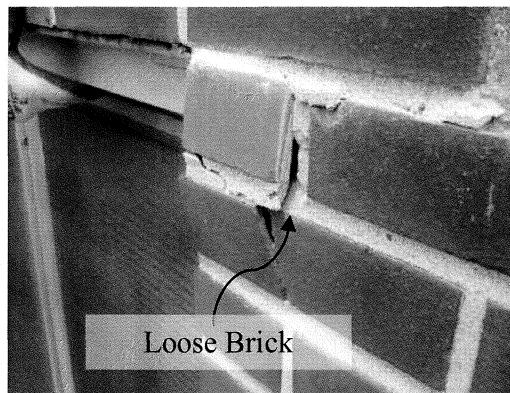
1. Deficiency: Loose Brick

- a. Description: Loose bricks were noted at locations of mechanical damage and areas where mortar had become loose on all four sides through weathering.
- b. Frequency: Typical
- c. Proposed Repair: Remove and re-set
- d. Estimated Repair Cost: $250 \text{ S.F.} \times \$8.00/\text{S.F.} = \$2,000.00$
Price shown is for cost of work only.
Refer to Section VIII for Estimate Qualifications.

Photograph 1: Typical Loose Brick

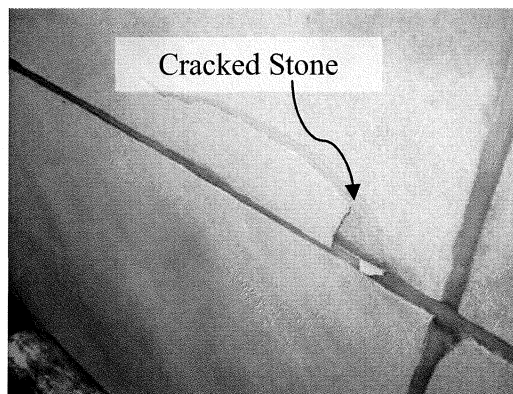
2. Loose/Cracked Stone

- A. Description: Cracking was noted throughout areas of stone facade.
- B. Frequency: Typical.
- C. Proposed Repair: Repair with epoxy.
- D. Estimated Repair Cost: $750 \text{ S.F.} \times \$20.00/\text{S.F.} = \$15,000.00$.
Price shown is for cost of work only.
Refer to Section VIII for Estimate Qualifications.

Photograph 2: Typical Cracked Stone Area

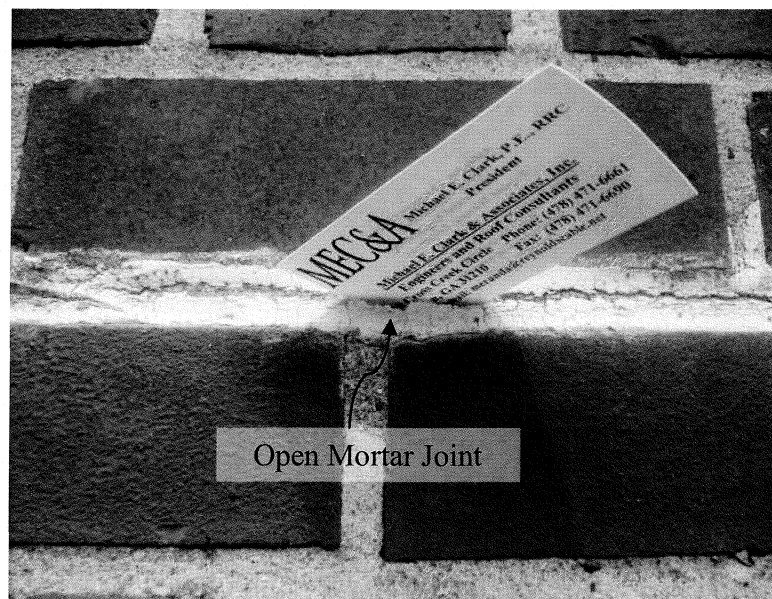
1. Deficiency: Open Mortar Joints

- a. Description: Open mortar joints are caused by volume changes due to thermal and moisture expansion and contraction as well as expansion caused by rusting reinforcing and the hydration of salts within the masonry.
- b. Frequency: Typical
- c. Proposed Repair: Re-pointing. The cracked mortar should be removed to sound substrate and the joint re-pointed with an appropriate mortar repair material.
- d. Estimated Repair Estimate: 18,490 L.F. x \$10/L.F. = \$184,900
Price shown is for cost of work only.
Refer to Section VIII for Estimate Qualifications.

Photograph 3: Open Mortar Joint in Field of Facade

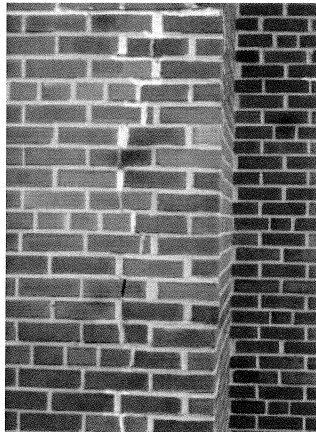
2. Deficiency: Vertical & Diagonal Cracks

- a. Description: Vertical and diagonal cracks of varying severity and age were often noted at the end and in the field of the walls. Typically, longer walls had larger and more pronounced cracks. While some cracks appeared in the field of the brick, most of the cracks appeared at the ends and corners of walls where resistance to volume changes is resisted by bending rather than compression of the brick veneer. Vertical and diagonal cracks should be routed and filled with an appropriate pointing compound.
- b. Frequency: Typical
- c. Proposed Repair: Router & Point
- d. Estimated Repair Cost: 1,250 L.F. x \$10/L.F. = \$12,500
Price shown is for cost of work only.
Refer to Section VIII for Estimate Qualifications.

Photograph 4: Typical Vertical Cracks in Brick

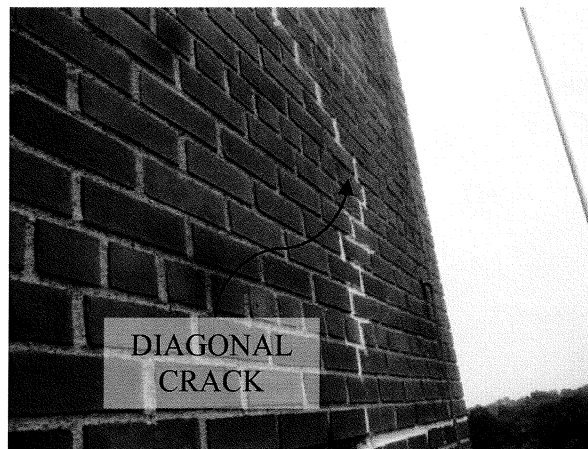
Photograph 5: Typical Diagonal Crack

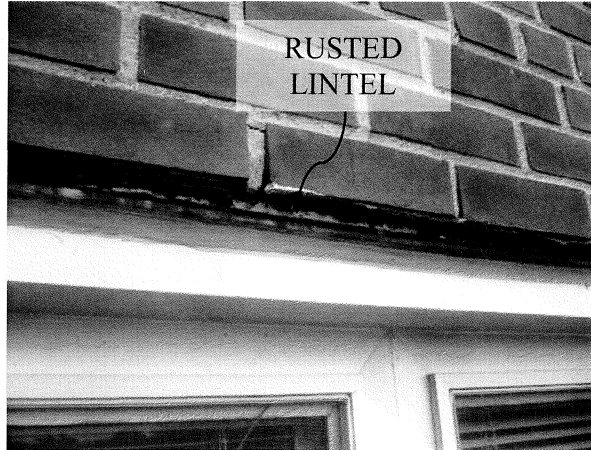
3. Deficiency: Rusted Steel Lintels at Windows

- a. Description: Window Lintels are rusted.
- b. Frequency: Typical
- c. Proposed Repair: Clean to blast clean appearance and coat with epoxy.
- d. Estimated Repair Cost: 6,012 L.F. x \$20.00/L.F. = \$120,240
Price shown is for cost of work only.
Refer to Section VIII for Estimate Qualifications.

Photograph 6: Typical Rusted Window Lintel

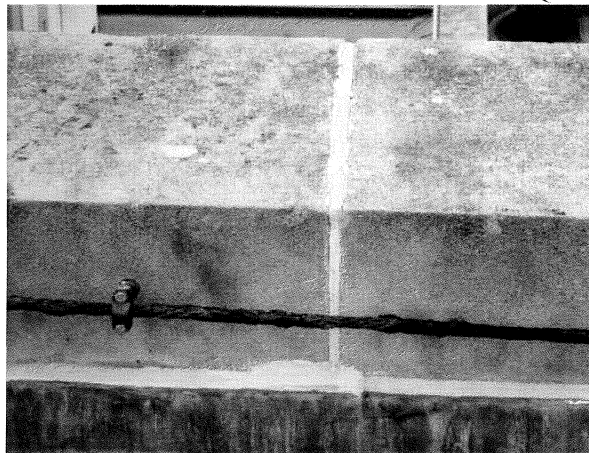
4. Deficiency: Failed Coping Cap Joint Sealant

- a. Description: Joint Sealant between parapet wall coping caps has failed allowing water entry.
- b. Frequency: Typical
- c. Proposed Repair: Remove and replace the failed joint sealant.
- d. Estimated Repair Cost: 972 L.F. x \$5/L.F. = \$4,860
Price shown is for cost of work only.
Refer to Section VIII for Estimate Qualifications.

Photograph 7: Typical Failed Coping Cap Joint Sealant

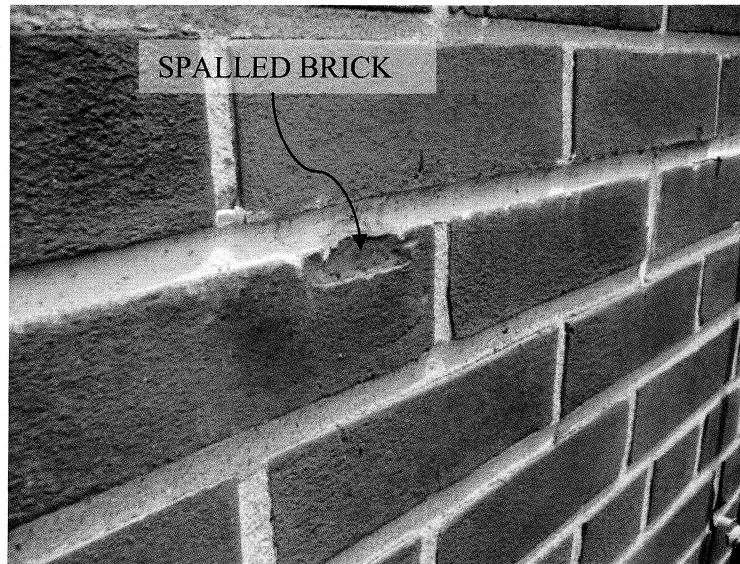
1. Deficiency: Spalled Brick

- a. Description: Spalling is the deterioration of a brick's surface brought on by the porous brick material absorbing moisture and then the brick's surface breaking apart, or spalling, when the water it absorbs expands due to freezing temperatures.
- b. Frequency: Typical
- c. Proposed Repair: Remove and replace.
- d. Estimated Repair Cost: $150 \text{ S.F.} \times \$450/\text{S.F.} = \$67,500$
Price shown is for cost of work only.
Refer to Section VIII for Estimate Qualifications.

Photograph 8: Typical Spalled Brick

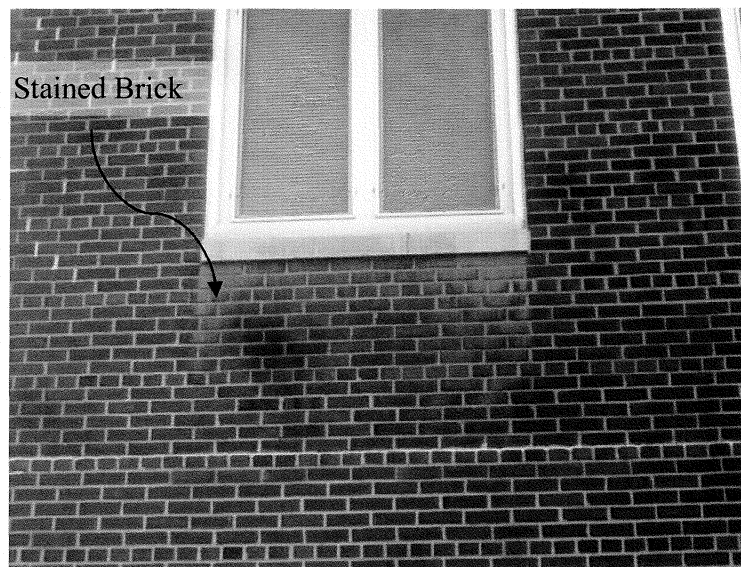
2. Deficiency: Stained Brick

- a. Description: Bricks are stained with mold, mildew, and efflorescence.
- b. Frequency: Typical.
- c. Proposed Repair: Since cleaning only the heavily soiled areas would result in a non-uniform façade appearance, the entire building should be cleaned. After cleaning, a water repellent sealer should be applied to prevent elevated moisture contents in the bricks and mortar joints. An ongoing maintenance practice of resealing the building at five year intervals could prolong re-pointing intervals.
- d. Estimated Repair Cost: $184,902 \text{ S.F.} \times \$1.50/\text{S.F.} = \$277,353$
Price shown is for cost of work only.
Refer to Section VIII for Estimate Qualifications.

Photograph 9: Typical Stained Brick at Window

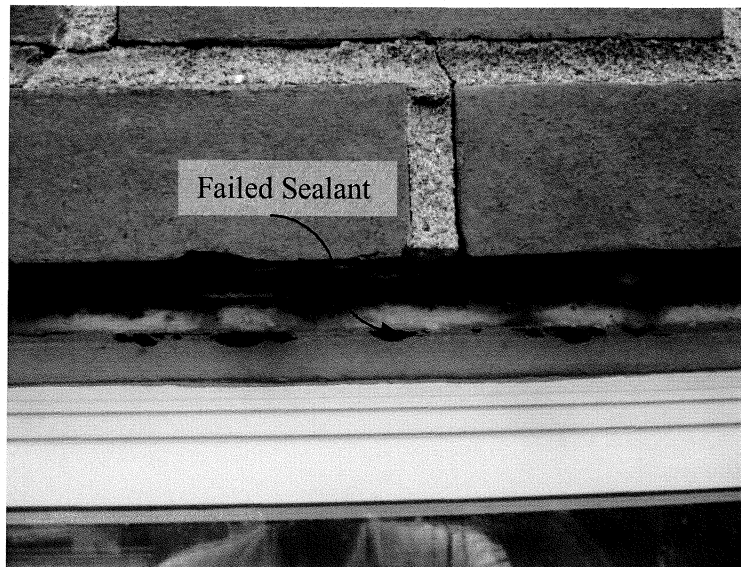
3. Deficiency: Sealant Around Windows

- a. Description: Sealant has failed around the perimeter of windows allowing water entry.
- b. Frequency: Typical
- c. Proposed Repair: Remove and Re-seal.
- d. Estimated Repair Cost: 20,040 L.F. x \$4.50/L.F. = \$90,180
Price shown is for cost of work only.
Refer to Section VIII for Estimate Qualifications.

Photograph 10: Typical Failed Sealant

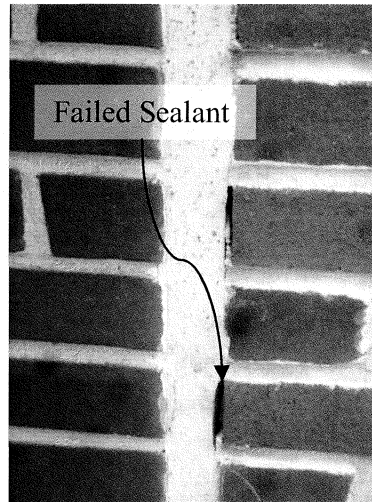
4. Deficiency: Failed Joint Sealants

- a. Description: Vertical Building expansion joint sealants have failed as have the joints between the stone façade panels.
- b. Frequency: Typical
- c. Proposed Repair: Remove and Replace.
- d. Estimated Repair Cost: 8,600 L.F. x \$10/L.F. \$86,000
Price shown is for cost of work only.
Refer to Section VIII for Estimate Qualifications.

Photograph 11: Typical Failed Building Joint Sealant

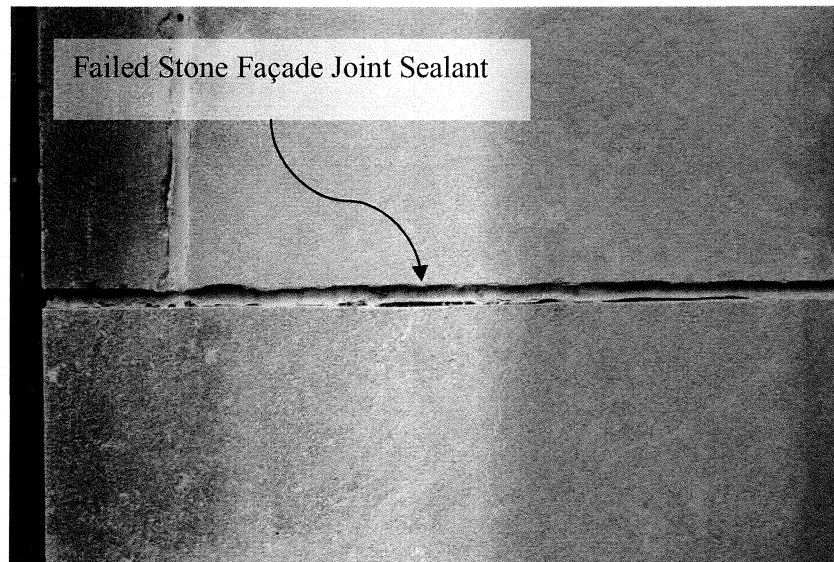
Photograph 12: Typical Failed Stone Façade Joint Sealant

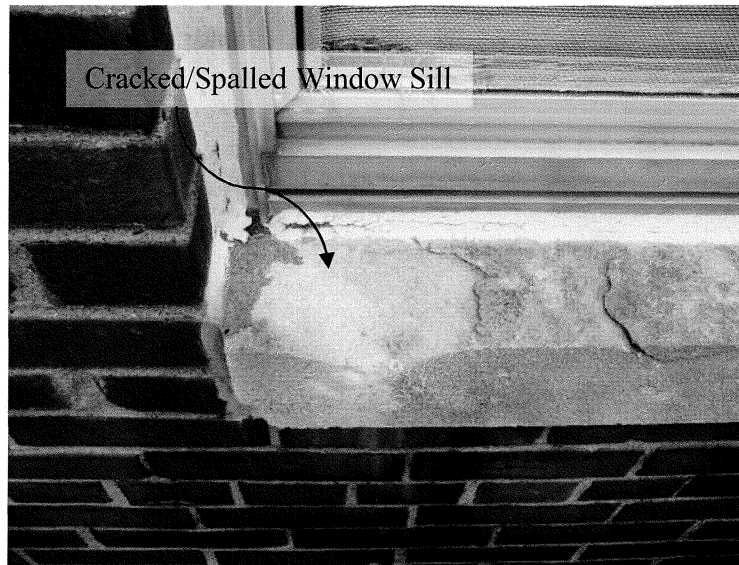
5. Deficiency: Cracked/Spalled Window Sills

- a. Description: Water Entry into the cast stone window sills has caused cracking and spalling due to freeze/thaw.
- b. Frequency: Typical
- c. Proposed Repair: Re-build sills with epoxy.
- d. Estimated Repair Cost: 750 S.F. x \$20/S.F. = \$15,000
Price shown is for cost of work only.
Refer to Section VIII for Estimate Qualifications.

Photograph 13: Typical Cracked/Spalled Window Sill
